Residential Tenancy Entry Condition Report

1 Smith Street, Townsville City, Queensland 4810

Report completed on Sunday 06/10/2024

Entry condition report – general tenancies (Form 1a)

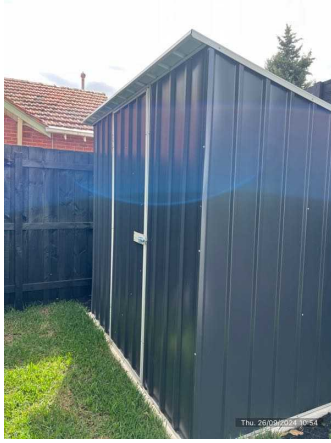
General - Outside Back: Storage shed (photo 1 of 1)

Rubbish bin				To be delivered ETA 30/9/24	Y	
Green waste				To be delivered ETA 30/9/24	Y	
Recycling bins				To be delivered ETA 30/9/24	Y	
Storage shed	Y	Y	Y	1x black metal storage shed with grey roof. Good condition with no visible damage. (1 photo, page 55)	Y	Items left in shed (1 photo, page 57)
