104/10 Transfer Street, Collingwood, VIC 3066

Report completed on Sunday 22/01/2023

Prepared by Nikki Atzori

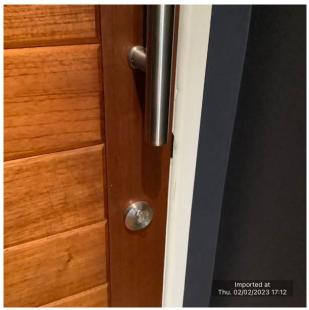
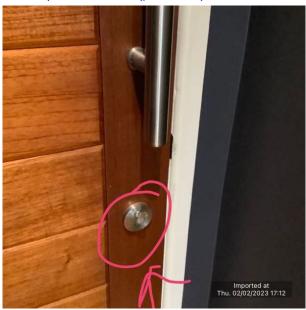
#1 - Entry: Front door locks (photo 1 of 2)

Entry	
#1 Front door locks	Broken front door lock
	(2 photos, page 5)
#2 Walls	Crack in wooden slat in entry way
	(2 photos, page 5)

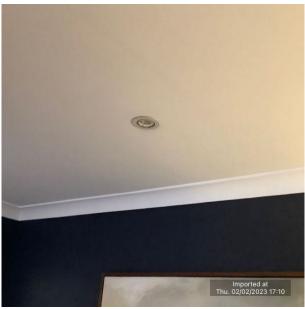
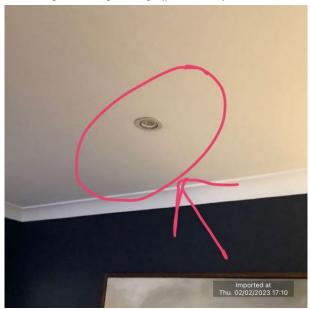
#3 - Lounge room: Light fittings (photo 1 of 2)

Lounge room	
#3 Light fittings	Light fitting needs replacing
	(2 photos, page 6)

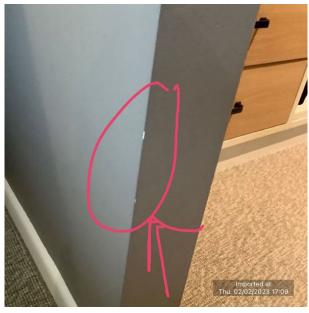
#5 - Master Bedroom: Walls (photo 2 of 2)

Master Bedroom	
#6 Walls	Chip in wall in master bedroom
	(2 photos, page 6)

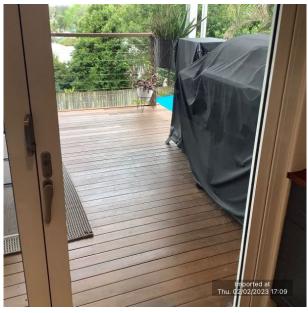
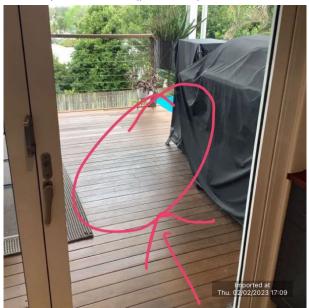
#6 - Study Nook: Windows (photo 1 of 2)

Study Nook	
#7 Windows	Crack in window in study nook
	(2 photos, page 6)

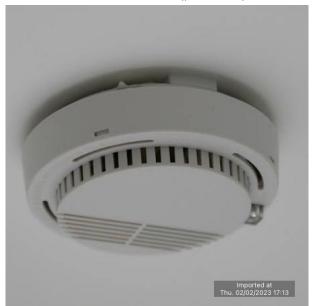
**General - Inside:** Smoke detectors (photo 1 of 1)

General - Inside	
Smoke detectors	Sighted (1 photo, page 23)
