Residential Tenancy Entry Condition Report

1 Smith Street, Townsville City, Queensland 4810

Report completed on Sunday 06/10/2024

Entry condition report – general tenancies (Form 1a)

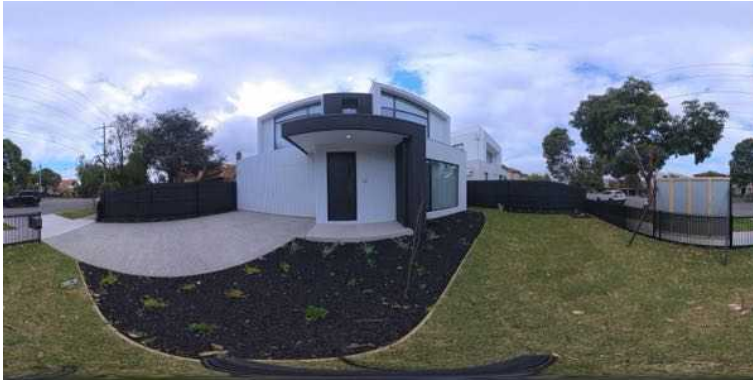
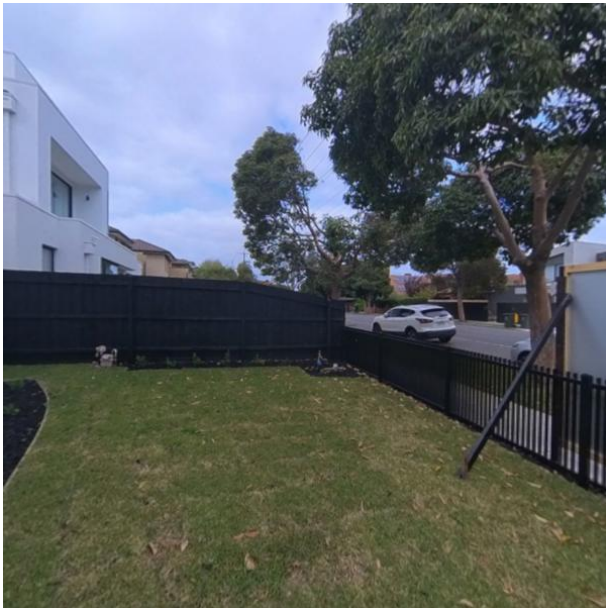
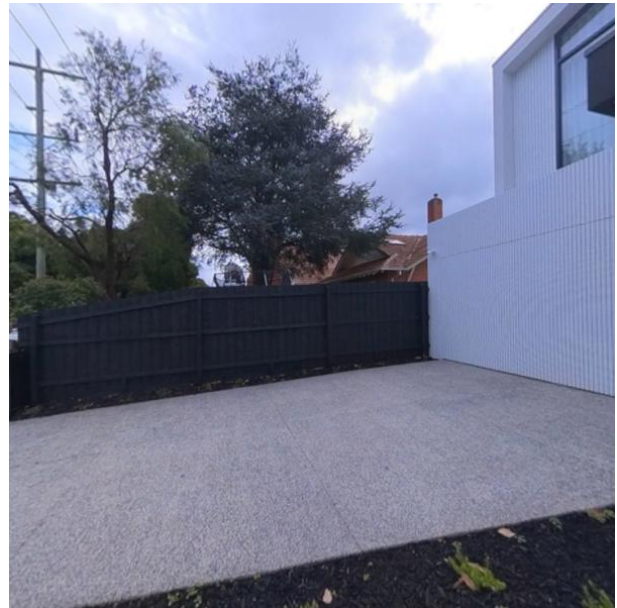
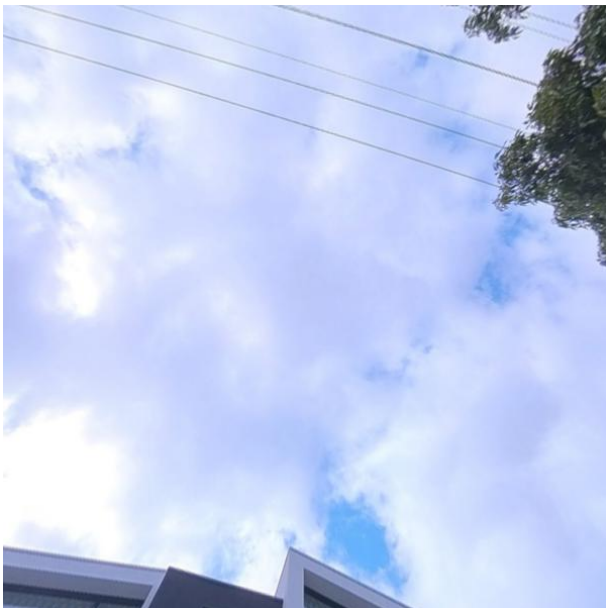
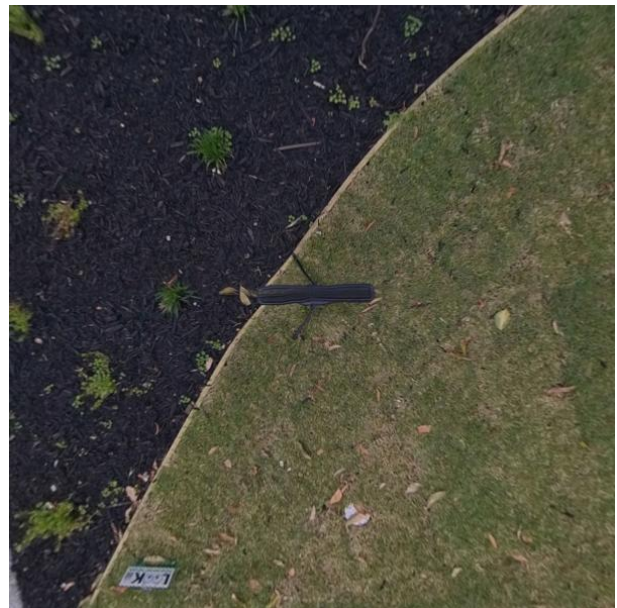
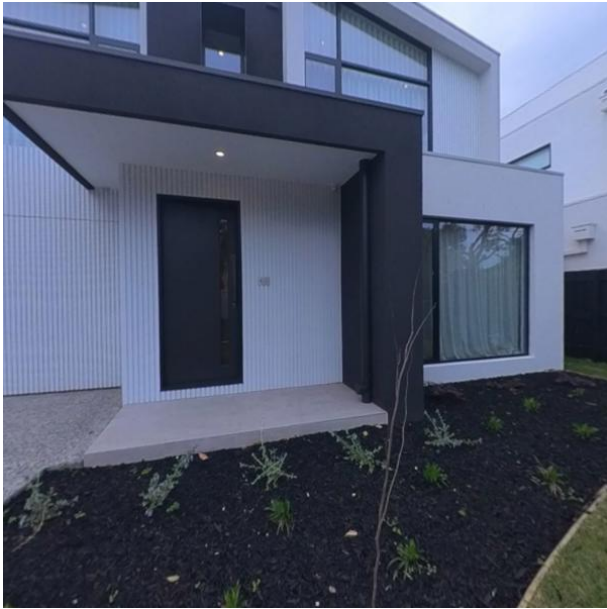
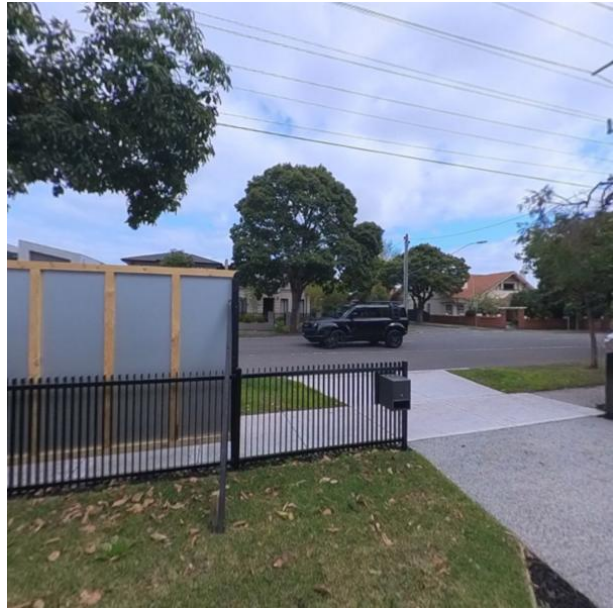
General - Outside Front: (360° photo 1 of 1)

Agent section				Renter section		
Each item has been given a column description of 'clean', 'undamaged', 'working'. Tick each column that applies to the item and make any necessary comments.				If you disagree with the agent's report of an item, make a comment in this section. You should also note anything which seems unsafe or may be an injury risk.		
General - Outside Front	Cln	Udg	Wkg	Agent comments <i>Cln = Clean, Udg = Undamaged, Wkg = Working</i>	Renter agrees	Renter comments <i>Renter initially reviewed at 19:39 Sunday 06/10/2024</i>
Overall				(1 360° photo, page 12)		
Balcony/porch	Y	Y	Y	Raised concrete porch at entrance, appearing to be in good condition with no visible marks or damage.	Y	
Garage/car port	Y	Y	Y	Double garage visible on the right side of the Overview photo. White metal garage door in good condition with no visible damage.	Y	
Gates/fences	Y	Y	Y	Black metal fence and gate in good condition. No visible rust or damage.	Y

Letterbox	Y	Y	Y	Single black letterbox integrated into the fence, in good condition with no visible damage.	Y	
Front garden	Y	Y	Y	Front garden with freshly planted shrubs and new mulch. No visible damage or issues.	Y	Weeds emerging in front garden bed. (1 photo, page 57)
Back and side garden	Y	Y	Y	Back and side garden visible in Overview photo. Lawn area bordered by garden beds. Good condition with no visible damage.	Y	
Car park	Y	Y	Y	Car park area visible in Overview photo. Concrete driveway in good condition with no visible damage.	Y	
Front Entrance	Cln	Udg	Wkg	Agent comments <i>Cln = Clean, Udg = Undamaged, Wkg = Working</i>	Renter agrees	Renter comments <i>Renter initially reviewed at 19:40 Sunday 06/10/2024</i>
Overall				(1 360° photo, page 13)		
Front door	Y	Y	Y	Black timber front door with 1 lock. Good condition with no visible marks or damage.	Y	
Walls	Y	Y	Y	White painted walls in good condition with no visible marks or damage.	Y

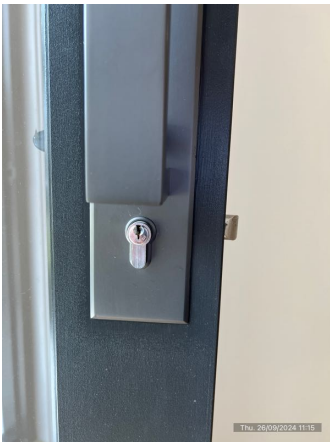
Entrance Hall: Front door locks (photo 1 of 1)

Ceiling	Y	Y	Y	White painted ceiling in good condition with no visible marks or damage.	Y	
Light fittings	Y	Y	Y	1x white recessed downlight in good condition.	Y	
Floor coverings	Y	Y	Y	Beige tiled floor in good condition with no visible marks or damage.	Y	
Doorbell/Intercom/security phone	Y	Y	Y	Stainless steel doorbell/intercom with camera and speaker, brand Dorrani. In good condition. (1 photo, page 14)	Y	
Entrance Hall	Cln	Udg	Wkg	Agent comments <i>Cln = Clean, Udg = Undamaged, Wkg = Working</i>	Renter agrees	Renter comments <i>Renter initially reviewed at 19:43 Sunday 06/10/2024</i>
Overall				(2 360° photos, page 15)		
Front door	Y	Y	Y	Black painted timber front door with a frosted glass panel. Good condition with no visible marks or damage.	Y	
Front door locks	Y	Y	Y	Silver metal door lock with a keyhole located on the right side of the front door. Good condition with no visible wear. (1 photo, page 17)	Y	1 key is not usable - it does not turn in the lock. (1 photo, page 57)

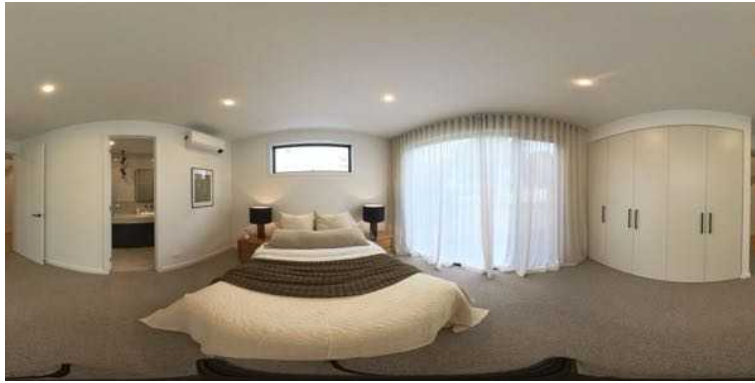
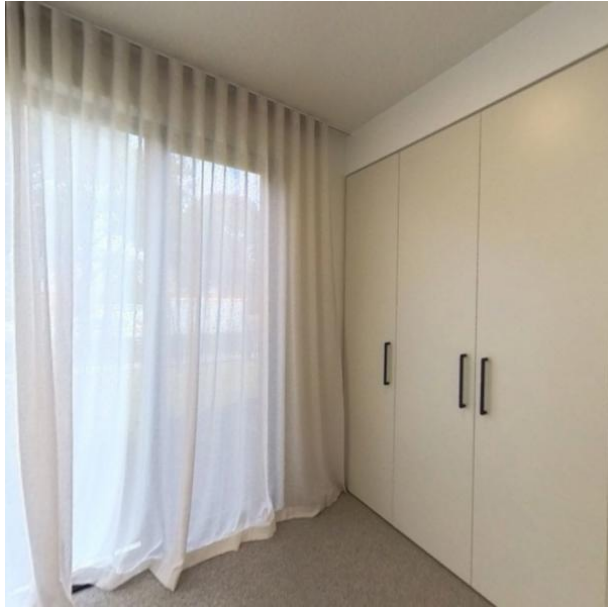
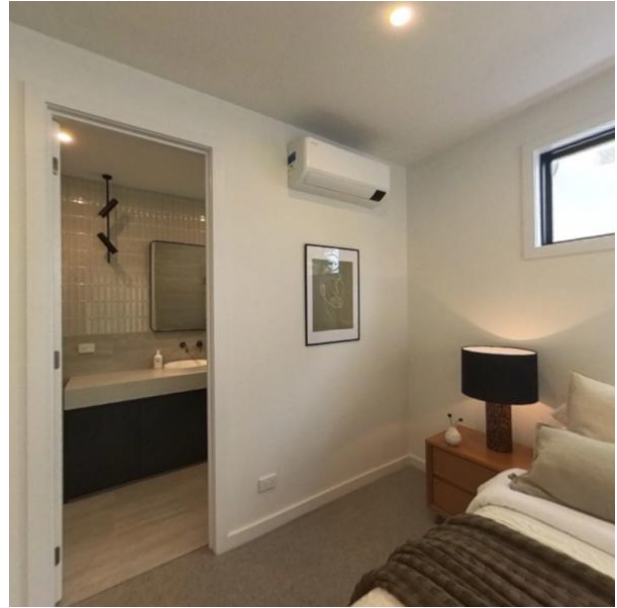
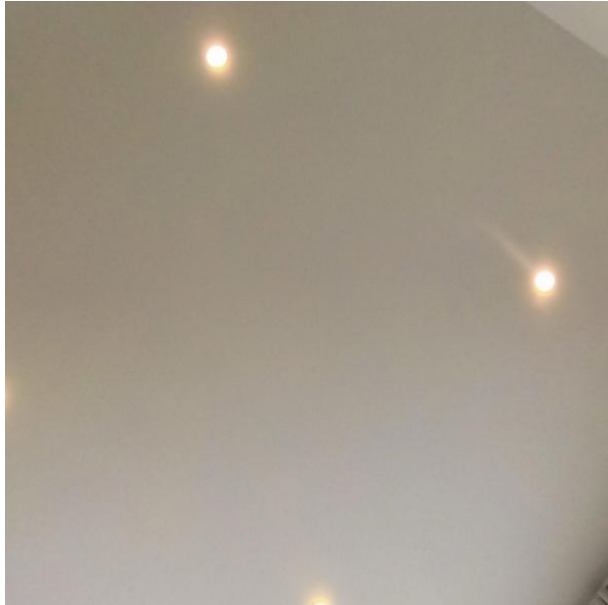
Bedroom 1: (360° photo 1 of 3)

Overall				(3 360° photos, page 18)		
Doors	Y	Y	Y	White painted timber doors with stainless steel handles. Good condition with no visible marks or damage.	Y

Walls	Y	Y	Y	White painted plaster walls in good condition. No visible marks or damage.	Y	
Skirting boards	Y	Y	Y	White painted timber skirting boards in good condition. No visible marks or damage.	Y	
Wardrobe/drawers	Y	Y	Y	Wardrobe with white painted timber doors and stainless steel handles. Inside features white melamine shelving and hanging rails, all in good condition with no visible marks or damage. (2 photos, page 22)	Y	
Windows	Y	Y	Y	Large fixed and sliding glass windows with aluminium frames. All in good condition with no visible marks or damage.	Y	
Screens	Y	Y	Y	Screens installed on sliding windows. All in good condition with no visible damage.	Y	
Window locks	Y	Y	Y	Window locks present on sliding windows. All in good condition and functional.	Y	
Blinds/curtains	Y	Y	Y	White sheer curtains in good condition with no visible marks or damage.	Y	
Ceiling	Y	Y	Y	White painted plaster ceiling in good condition. 4x white downlights installed, all functioning.	Y

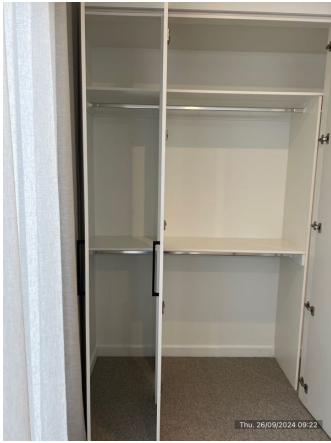
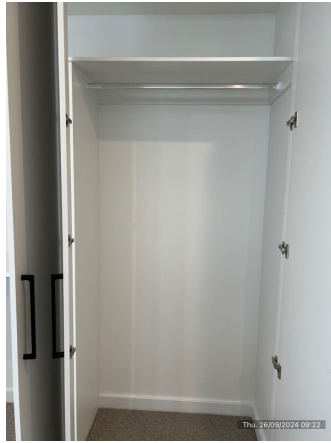
Bedroom 1: Wardrobe/drawers (photo 1 of 2)

Skirting boards	Y	Y	Y	White painted timber skirting boards in good condition with no visible marks or damage.	Y	
Wardrobe/drawers	Y	Y	Y	White built-in wardrobe with 4x doors, each with black handles. Wardrobe interior includes shelving and hanging rail. In good condition with no visible damage.	N	2nd door handle is loose (1 photo, page 57)
Windows	Y	Y	Y	2x large aluminium-framed windows with clear glass. In good condition with no visible damage.	Y	
Screens	Y	Y	Y	2x fly screens installed on windows. Screens are in good condition with no visible damage.	Y	
Window locks	Y	Y	Y	2x white window locks on aluminium-framed windows. Locks are in good condition and functional.	Y	
Blinds/curtains	Y	Y	Y	No blinds or curtains present on the windows.	Y	
Ceiling	Y	Y	Y	White painted plaster ceiling in good condition with no visible marks or damage.	Y	
Light fittings	Y	Y	Y	2x recessed white downlights, both functional and in good condition with no visible damage.	Y

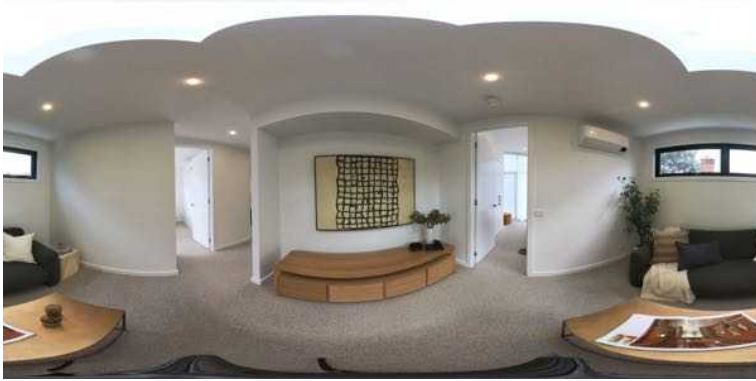
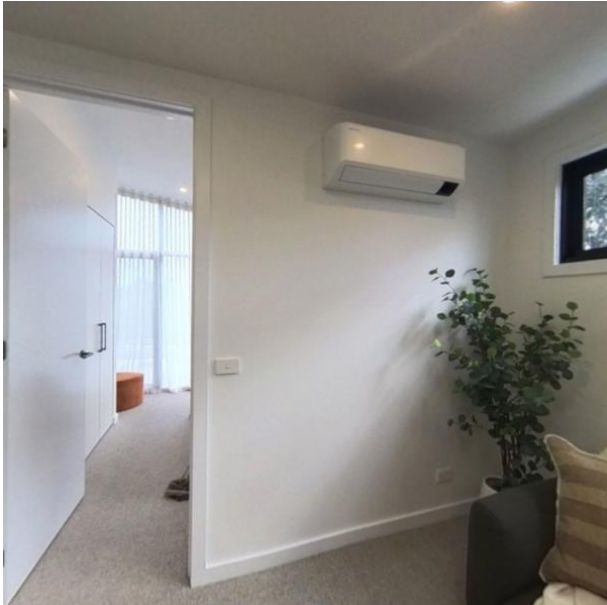
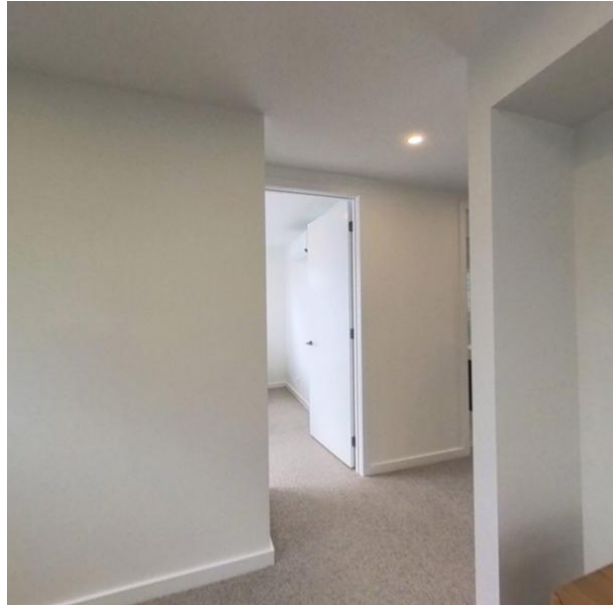
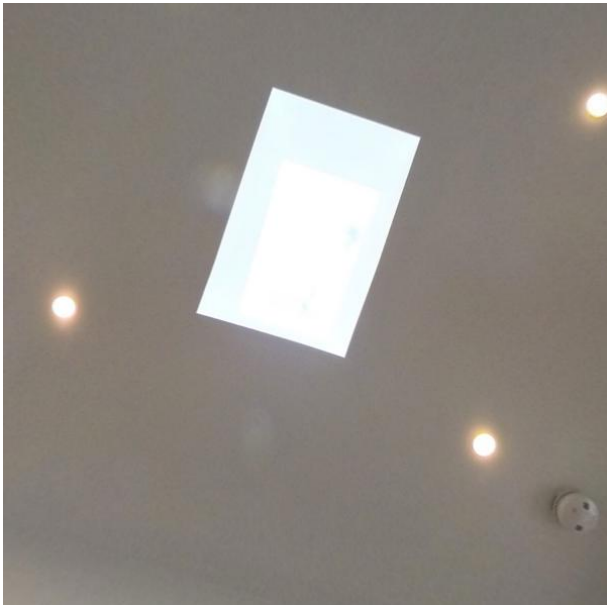
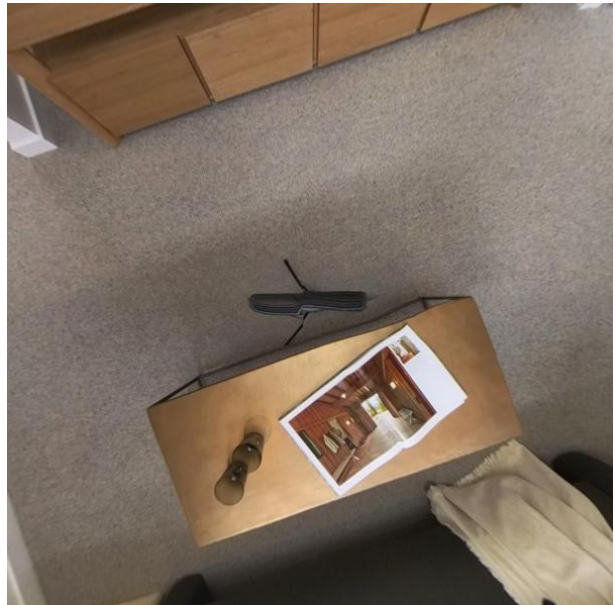
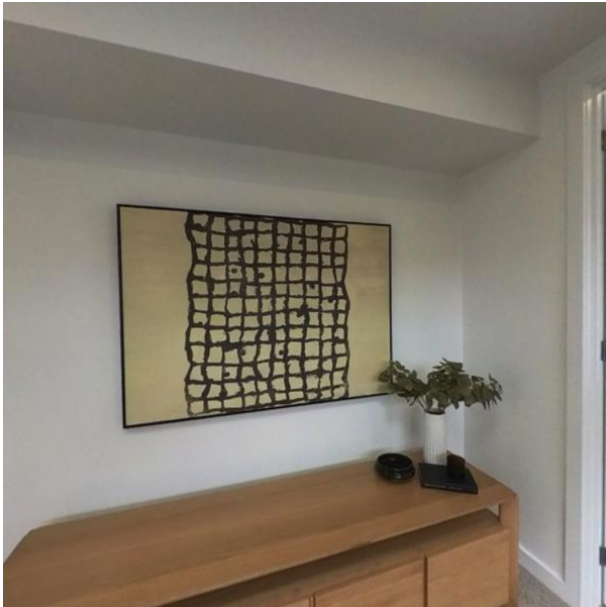
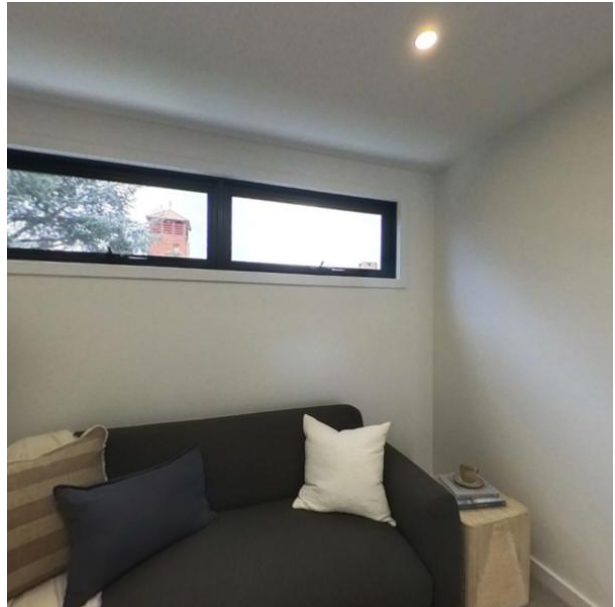
Upstairs Living: (360° photo 1 of 1)

Upstairs Living	Cln	Udg	Wkg	Agent comments <i>Cln = Clean, Udg = Undamaged, Wkg = Working</i>	Renter agrees	Renter comments <i>Renter initially reviewed at 20:06 Sunday 06/10/2024</i>
Overall				(1 360° photo, page 49)		
Doors	Y	Y	Y	White painted timber door with stainless steel handle, no lock. Good condition with no visible marks or damage.	Y	
Walls	Y	Y	Y	White painted plaster walls in good condition with no visible marks or damage. One section features a mounted artwork.	Y	
Skirting boards	Y	Y	Y	White painted timber skirting boards in good condition with no visible damage.	Y	
Picture hooks	Y	Y	Y	1x metallic picture hook in use holding a framed artwork. Good condition.	Y	
Windows	Y	Y	Y	2x aluminium framed windows, fixed, with no visible damage or marks.	Y	
Screens	Y	Y	Y	2x fly screens fitted to windows. Good condition with no visible tears.	Y	
Blinds/curtains	Y	Y	Y	2x roller blinds, beige, fitted to windows. Good condition with no visible stains or damage.	Y

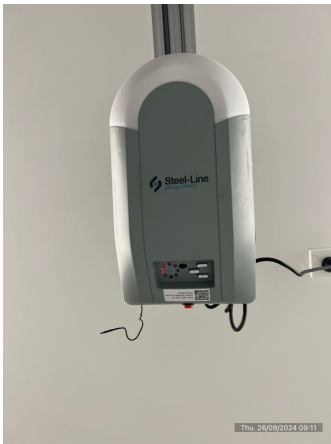
Garage: Garage overall (photo 1 of 1)

Garage overall	Y	Y	Y	Steel-Line garage door in good condition. White panelled surface with no visible damage. Equipped with Steel-Line garage door opener as shown in feature photo. (1 photo, page 53)	Y	
General - Outside Back	Cln	Udg	Wkg	Agent comments <i>Cln = Clean, Udg = Undamaged, Wkg = Working</i>	Renter agrees	Renter comments <i>Renter initially reviewed at 20:07 Sunday 06/10/2024</i>
Overall				(1 360° photo, page 53)		
Balcony/porch	Y	Y	Y	Small porch area visible near the sliding glass door. Contains a round metal table and two black metal chairs. All in good condition with no visible damage.	Y	
Gates/fences	Y	Y	Y	Tall black painted timber fence surrounding the backyard area. Fence in good condition with no visible damage.	Y	
Clothes line	Y	Y	Y	Wall-mounted foldable metal clothes line in good condition with no visible damage. (1 photo, page 55)	Y	
Back and side garden	Y	Y	Y	Back and side garden areas with small planted garden beds and well-maintained grass. Good condition with no visible issues.	Y

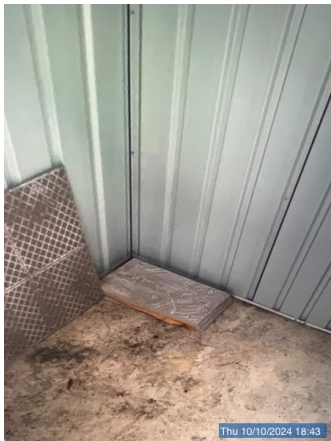
General - Outside Back: Storage shed (photo 1 of 1)

Rubbish bin				To be delivered ETA 30/9/24	Y	
Green waste				To be delivered ETA 30/9/24	Y	
Recycling bins				To be delivered ETA 30/9/24	Y	
Storage shed	Y	Y	Y	1x black metal storage shed with grey roof. Good condition with no visible damage. (1 photo, page 55)	Y	Items left in shed (1 photo, page 57)
