104/10 Transfer Street, Collingwood, VIC 3066

Report completed on Sunday 22/01/2023

Prepared by Nikki Atzori

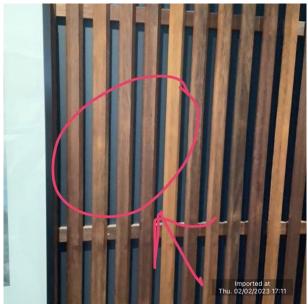
#2 - Entry: Walls (photo 2 of 2)

Entry	
#1 Front door locks	Broken front door lock
	(2 photos, page 5)
#2 Walls	Crack in wooden slat in entry way
	(2 photos, page 5)

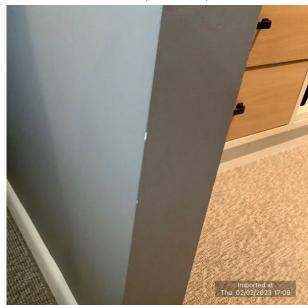
#5 - Master Bedroom: Walls (photo 1 of 2)

Master Bedroom	
#6 Walls	Chip in wall in master bedroom
	(2 photos, page 6)
